BESS manufacturing  
quality: Lessons learned  
from more than 30GWh  
of factory inspections

31st January 2024

# Lessons Learned From 30+ GWh BESS Quality Inspection

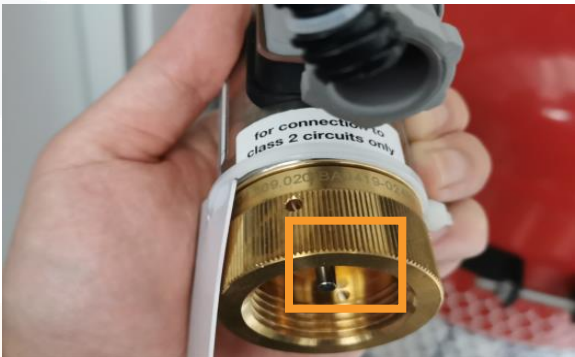
1. Fire extinguisher electric actuator

| No. | Finding Description | Root Causes | Risk Analysis | Corrective Action |
|---|---|---|---|---|
| 1 | Non-responding release actuator for the fire extinguishing agent. | <b>Faulty diode</b> within the actuator | System's disability in stop <b>early-stage fire propagation</b> . | Faulty diode was replaced. |

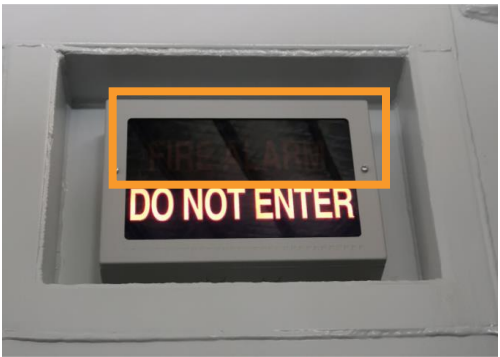
2. Fire alarm sign not lighting up

| No. | Finding Description | Root Causes | Risk Analysis | Corrective Action |
|---|---|---|---|---|
| 2 | Fire alarm sign didn't light up with a triggered alarm. | <b>Faulty internal components</b> | Deficiency in <b>visual fire emergency notification</b> . | The complete fire alarm sign was replaced with a new one. |

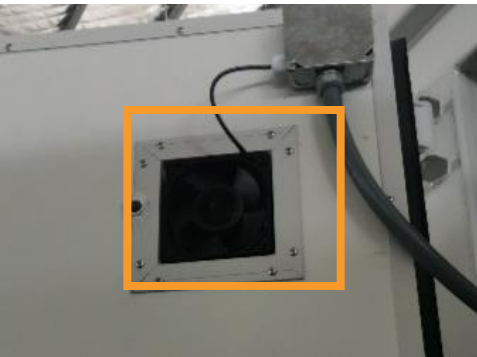
3. Hydrogen ventilation fan

| No. | Finding Description | Root Causes | Risk Analysis | Corrective Action |
|---|---|---|---|---|
| 3 | Reversely installed exhaust fans | <b>Mis-wiring</b> | Concentrated hydrocarbon gases that poses <b>fire and explosion risks</b> . | The ventilation system was correctly re-wired to allow efficient ventilation. |

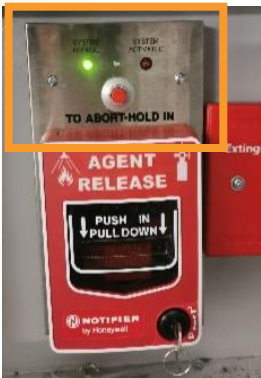
4. Fire alarm abort button

| No. | Finding Description | Root Causes | Risk Analysis | Corrective Action |
|---|---|---|---|---|
| 4 | Fire alarm abort button was not functional | <b>Mis-wiring</b> | Unwanted fire extinguishing agent release or sprinkler system activation, which was one of the contributing factor that caused the thermal runaway incident for " <b>Moss Landing Phase I</b> ". | The emergency abort button wiring was corrected. |

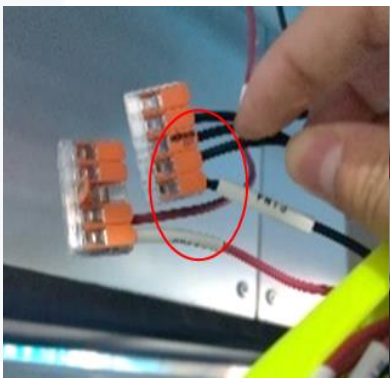
5. Non-responding gas and heat sensors due to mis-wiring

| No. | Finding Description | Root Causes | Risk Analysis | Corrective Action |
|---|---|---|---|---|
| 5 | Non-responding smoke and temperature sensors | <b>Mis-wiring</b> | System's disability in <b>detecting thermal runaway at early stage</b> . | Smoke and temperature sensors wiring were corrected. |

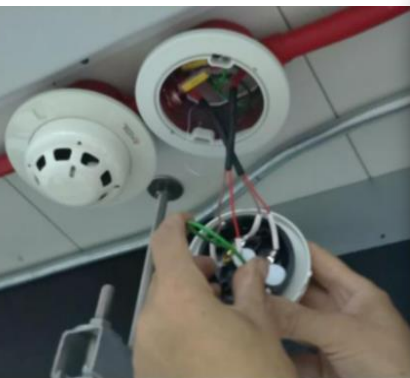
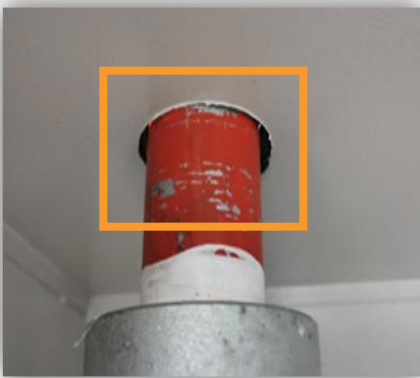
6. Missing rubber sleeve

| No. | Finding Description | Root Causes | Risk Analysis | Corrective Action |
|---|---|---|---|---|
| 6 | Fire suppression system pipe had no protective rubber sleeve | <b>Operational error</b> | <p>Direct metal-to-metal contact can cause friction leading to pipe damages that can result in fire extinguishing agent leakages onto the battery racks/modules. Given that the FSS pipe contains water, leakages onto battery racks may cause short circuiting that can lead to fire accidents.</p> <p>An example also comes from the "<b>Moss Landing Phase II</b>" where a leaking hose caused the suppression system to release water on battery racks.</p> | Rubber sleeves were installed on pipes to prevent direct contact. |

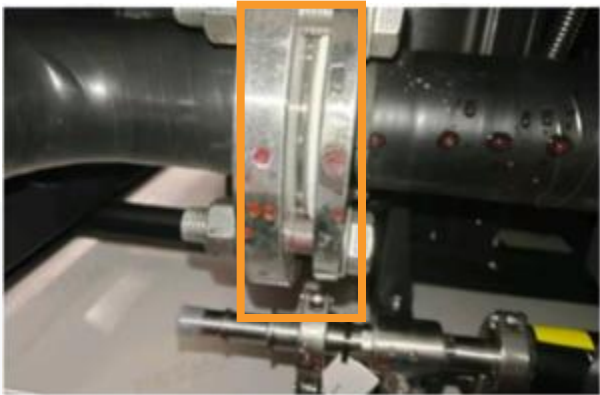
1. Leakage due to deformed flange plates

| No. | Finding Description | Root Causes | Risk Analysis | Corrective Action |
|---|---|---|---|---|
| 1 | <b>Deformed flange plates</b> | The flanges were deformed from overtightening due to a loosely defined screw mounting SOP (Standard Operating Procedure). | <b>Internal short circuiting</b> and <b>thermal runaway initiation</b> from continuous coolant leakage. | <ul style="list-style-type: none"><li>• Ring flanges were replaced and re-tested for leakage proof.</li><li>• Screw mounting SOP was revised to avoid overtightening</li></ul> |

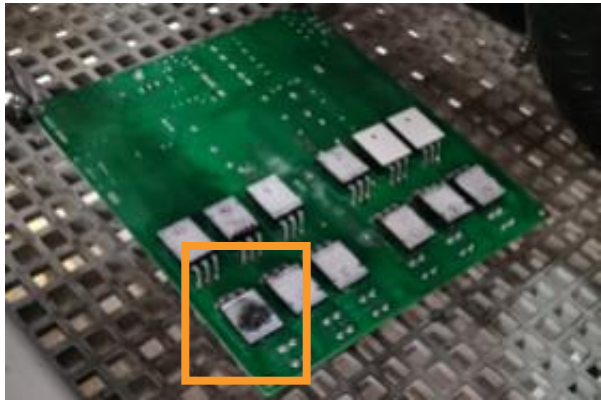
2. Compressor mainboard short circuiting

| No. | Finding Description | Root Causes | Risk Analysis | Corrective Action |
|---|---|---|---|---|
| 2 | <b>Compressor mainboard short circuiting</b> | Defective compressor mainboard | <b>Faster battery degradation</b> from unfunctional liquid cooling system. | <ul style="list-style-type: none"><li>• The mainboard was replaced</li><li>• Incoming quality control procedures were tightened for the related compressor supplier.</li></ul> |

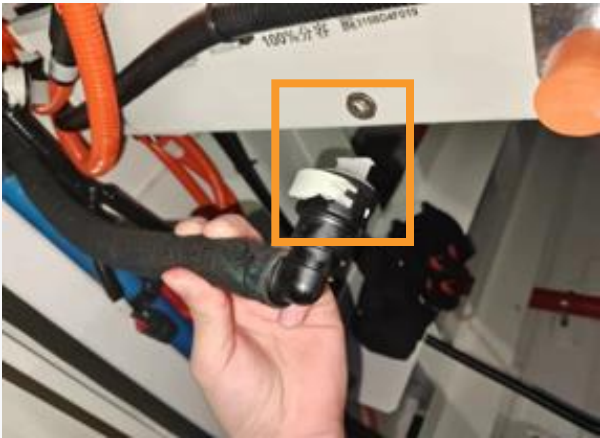
3. Loose pipe connection

| No. | Finding Description | Root Causes | Risk Analysis | Corrective Action |
|---|---|---|---|---|
| 3 | <b>Loose pipe connections</b> | The fastener was not fastened from operator's mis-installation and not following SOP. | <b>Severe short-circuiting events</b> and <b>thermal runaway initiation</b> from potential massive coolant leakage. | <ul style="list-style-type: none"><li>• Reinforced operator training on the installation SOP.</li><li>• An in-depth quality inspection on potential leakage-prone points was conducted.</li></ul> |

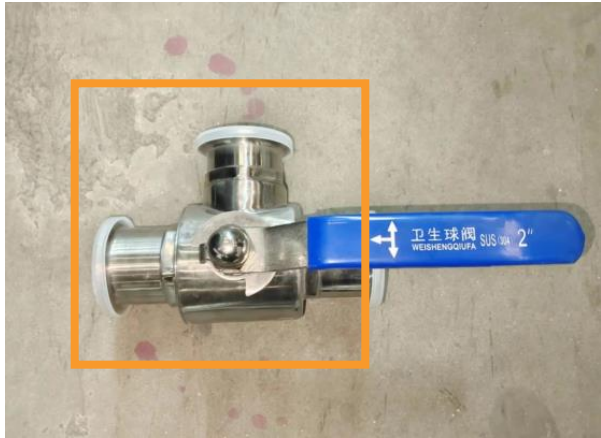
4. Leakage due to a defective valve

| No. | Finding Description | Root Causes | Risk Analysis | Corrective Action |
|---|---|---|---|---|
| 4 | <b>Defective three-way valve</b> | Defective incoming material: the valve comes with a loose stem. | <b>Faster battery degradation</b> from insufficient coolant flow control.<br><b>Internal short circuiting</b> and <b>thermal runaway initiation</b> from continuous coolant leakage. | <ul style="list-style-type: none"><li>• The defected valve was replaced</li><li>• Incoming quality control procedures were tightened for the valves.</li></ul> |
